## SIL MT102-01 Service Information Letter for MT102 Magnetic Transducer Accessory

Date: March 13, 2014  
Regarding: MT102 Cable  
SIL Revision: A

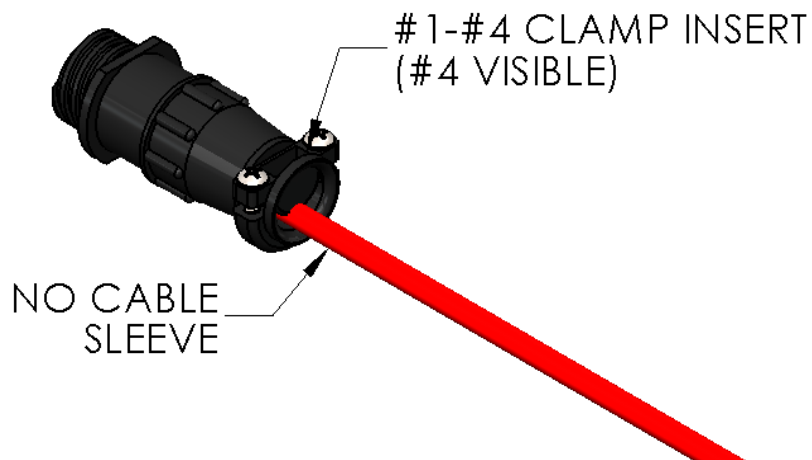
The cause of this issue is excessive clamping force on the MT102 cable clamp. This Service Information Letter provides a procedure to address possible excessive clamping force on the MT102 cable.

This Service Information Letter is applicable to MT102 units that do not have a sleeve on the cable installed by Sandel as shown in the following image.

Without the presence of a cable sleeve on the MT102 cable, there may be excessive clamping force on the cable resulting in shorting of the individual wires in the cable bundle. To alleviate this potential issue, the cable clamp force may be reduced by loosening the two screws on the clamp.

Back the screws out until they are loose and then retighten them until the clamp contacts the cable while not exerting excessive force. The screws should just be snug. The distance between the connector housing and the cable clamp should be approximately 0.125" as shown in the following image.
