## SB MT102-02 Service Bulletin for MT102 Magnetic Transducer Accessory

Date: March 28, 2014  
Regarding: MT102 Cable  
SB Revision: A

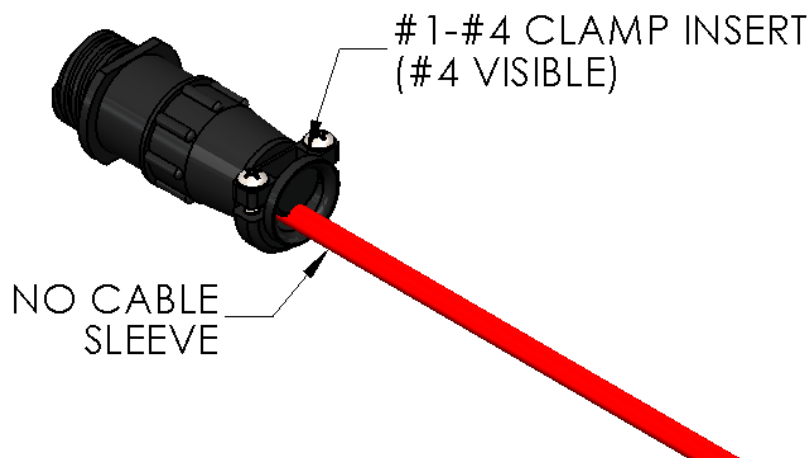
This Service Information Letter is applicable to MT102 units that do not have a sleeve on the cable installed by Sandel as shown in the following image.

Without the presence of a cable sleeve on the MT102 cable, there may be excessive clamping force on the cable resulting in shorting of the individual wires in the cable bundle. To alleviate this potential issue, the cable clamp force may be reduced by loosening the two screws on the clamp.

Back the screws out until they are loose and then retighten them until the clamp contacts the cable while not exerting excessive force. The screws should just be snug. The distance between the connector housing and the cable clamp should be approximately 0.125" as shown in the following image.

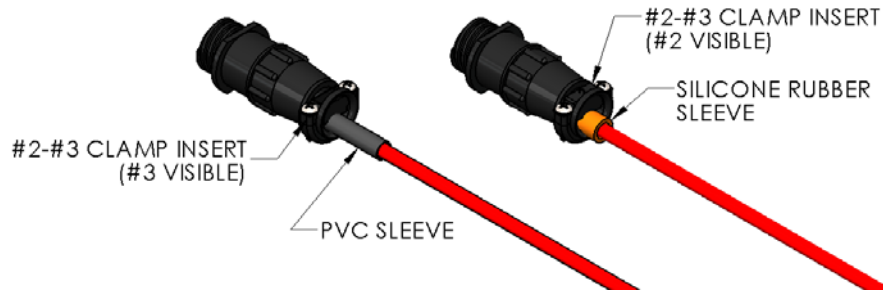
This Service Information Letter is not applicable to MT102 units with a sleeve on the cable as shown in the following image.
