SANDEL

SN3308 Pilot's Guide

Effectivity and Errata

Date: 4/15/2002
Revision: 2.10
Applies to: SN3308 Software 2.10
Pilot's Guide 82001PG-C
90106PG-C

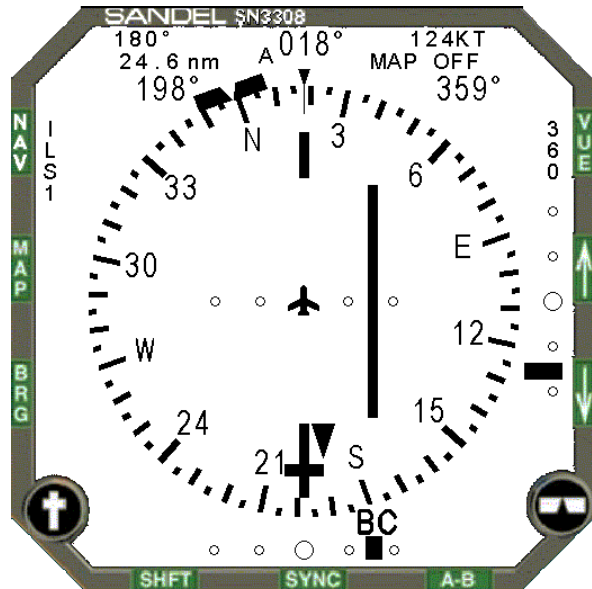
3. Back Course Approach Operation:

When flying a back course approach, the course pointer should be set to the published front course. In software versions 2.10 and later, the bottom CDI will automatically reverse sense when the course pointer is more than +/-90 Deg from the lubber line. The label 'BC' will appear above the bottom CDI during a back course approach as a reminder to the pilot as shown in the diagram below.
