SERVICE BULLETIN SB 3308-02

Explanation: Regulator failures have been reported after installation of replacement lamp at normal replacement interval using Lamp Kit SPN 90122. Failure is related to stamped code on component L4.

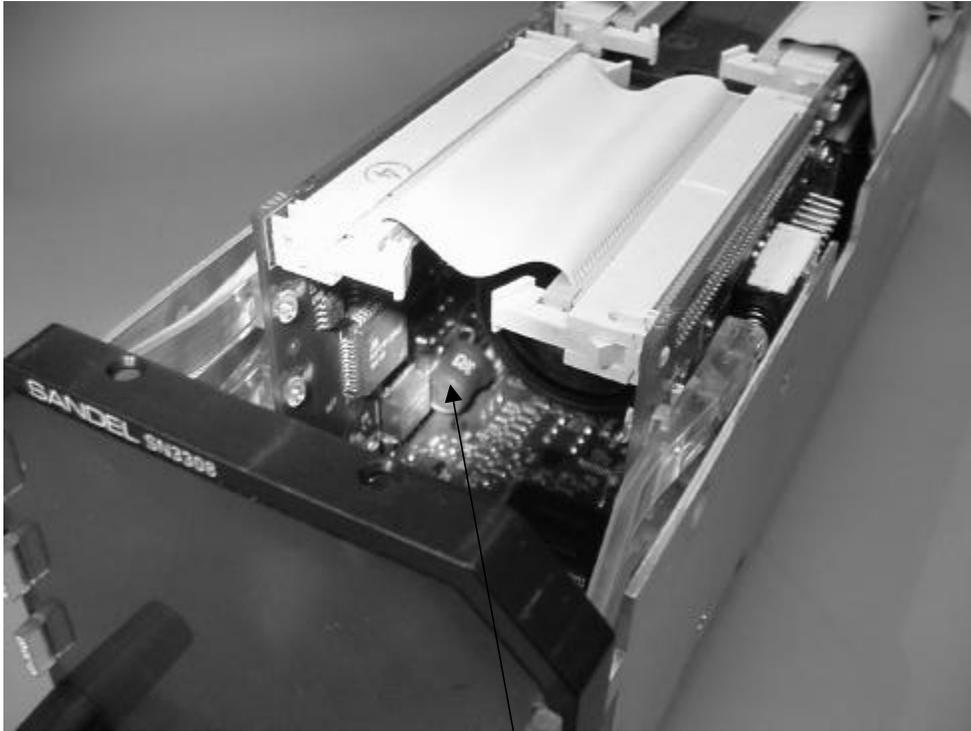
LOCATION OF
COMPONENT L4

1. Follow the disassembly instructions in the SN3308 Lamp Replacement Kit or SN-3308 Installation Manual. After removal of the top cover, perform the following steps.
2. Refer to attached photograph for position of affected component (L4).
3. This component will be stamped “100” or “3R3”. Visually confirm the stamped code. A partial identification (i.e. using one or more of the 3 characters) is acceptable if the stamped code is not fully in view.
4. If the stamped code is determined to be “3R3”, perform the balance of the normal lamp replacement (if required) and return the unit to service.
5. If the stamped code contains a “1” or “0” or the code cannot be verified, the unit must be **returned** to Sandel for repair.
