## SIL MT102-01 Service Information Letter for MT102 Magnetic Transducer Accessory

Date: March 13, 2014  
Regarding: MT102 Cable  
SIL Revision: A

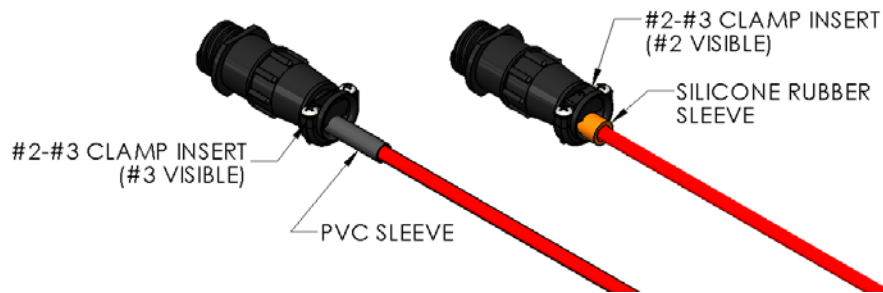
This Service Information Letter is not applicable to MT102 units with a sleeve on the cable as shown in the following image.
